Manhole Inspection Summary

Manhole # S45MM_049MH

Inspection ☐ Is Incomplete Rating: **3) Fair**

Insp Date: **3/25/08 12:24 PM**

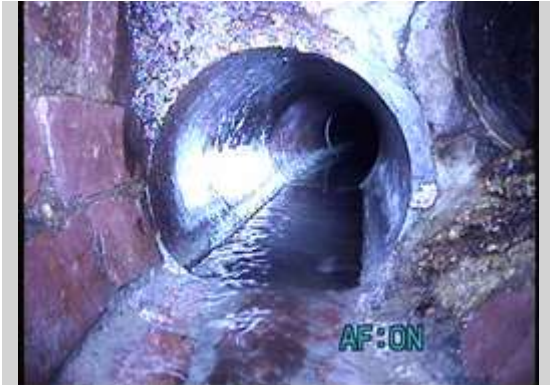
12 O'Clock Outflow

8 in. Circular Gravity Sewer
Pipe Out @ 12 O'Clock

Pipe Height: **8.4** (in.) Rod and Bar (Angled)
Pipe Material: **Clay** ☐ Pipe Lined
Invert Depth: **12.50** (ft.) Flow Characteristics: **Fast**
Deposits: ☒ None ☐ Mud ☐ Sludge ☐ Debris ☐ Grease
Silt Depth: (in.) Deposits Extent:
Infiltration: **None** Pipe Seal Cond: **Sound**

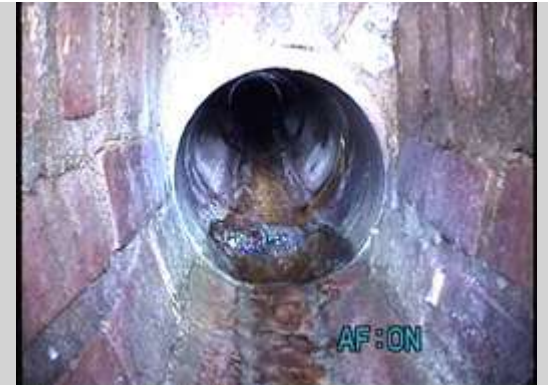
5 O'Clock Inflow

8 in. Circular Gravity Sewer

Pipe In @ 5 O'Clock

Pipe Height: **8.4** (in.) Rod and Bar (Angled)

Pipe Material: **Clay** ☐ Pipe Lined

Infiltration: **None** Pipe Seal Cond: **Sound**
